MOISTURE INDUCED BLISTERING

TECH PAPER

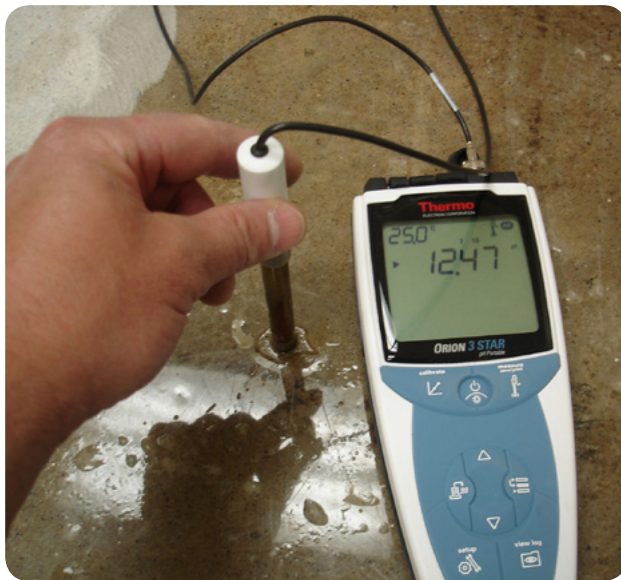
Water-soluble materials available for feeding osmotic blisters are typically made up of either inorganic or soluble organic elements. Inorganic soluble ions (e.g. sodium potassium, or chloride) that are found in higher concentrations at or near the surface of the concrete may be the result of the initial mix design, surface treatments such as silicate-based densifiers, acid etching, de-icing salts, etc. Soluble salts from the concrete mix design itself can migrate to the surface of the substrate where they concentrate during the slab's curing & drying period- similar to the formation of efflorescence on bricks. The process of finishing the concrete slab and the natural evaporation of moisture on or close to the surface means there will most always be a measurably higher level of soluble salt concentration in the uppermost portion (0-3+mm) of the flooring substrate.
